# ENHANCED PUMP AND TREAT SYSTEM

FORMER PETROLEUM REFINERY PLANT

Case History, No. 23

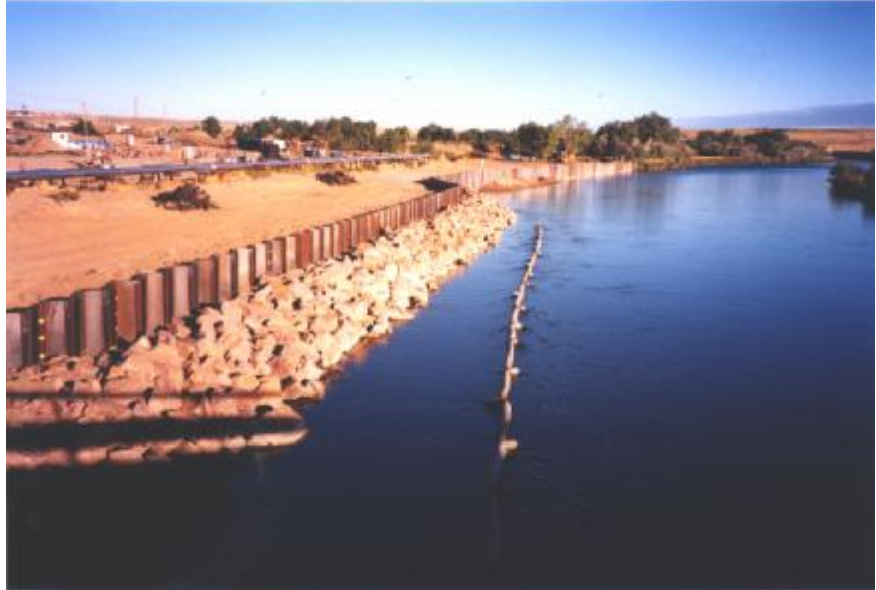
Figure 1: Cutoff Wall and Pump and Treat System

The Waterloo Barrier<sup>®</sup> was selected after a feasibility study involving a technical evaluation of various barrier technologies was conducted. The overall length of the cutoff wall was approximately 3,400 lineal feet, which included 2,800 lineal feet installed along the bank of the river. The cutoff wall fully penetrated the alluvial aquifer and keyed into bedrock that was at depths of 10 to 40 feet. A tremmie

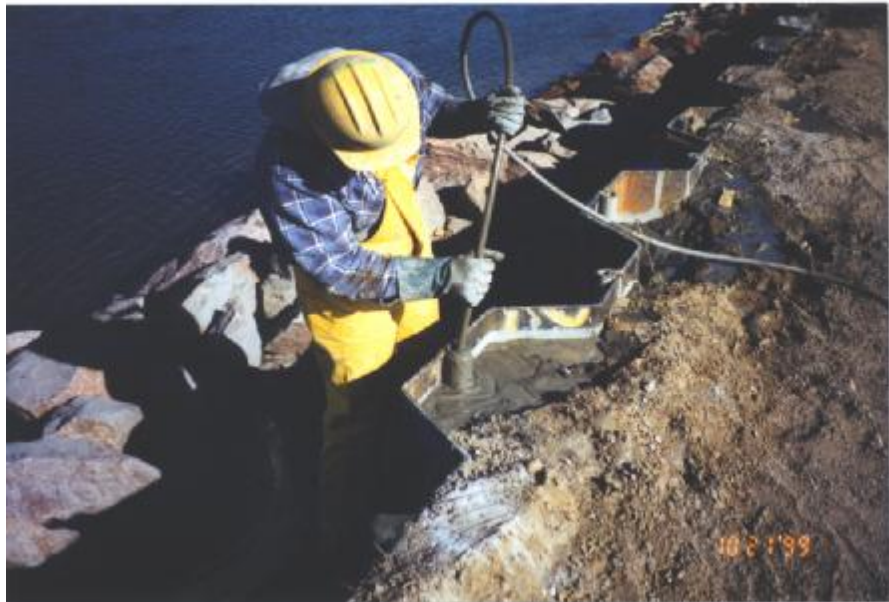
Figure 2: Typical Grout Process

pipe and packer assembly was then used to force the grout through the foot plates along the base of the piling to seal the wall where it keys into the bedrock, Figure 2.

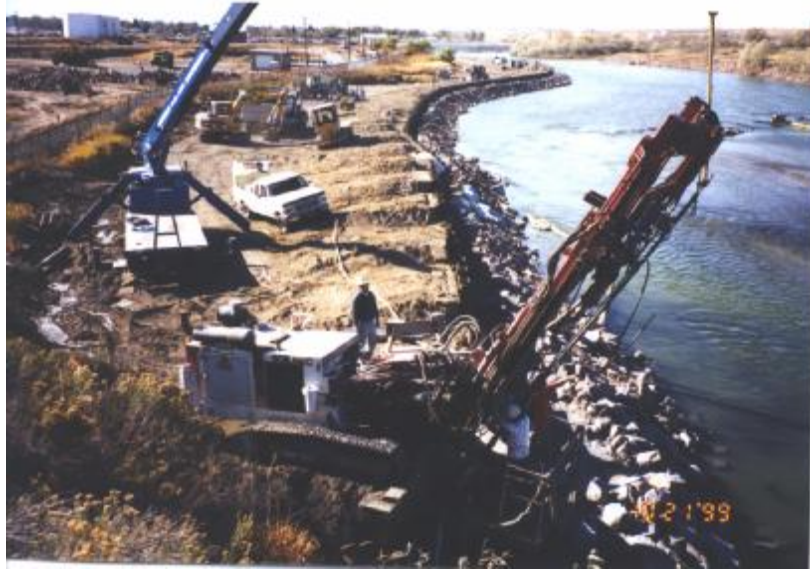
**Figure 3: Installation of Tie Rods**

The barrier also acted as a structural shoring system that consisted of walers, tie rods and rock anchors, Figure 3. Upon completing the pile driving and joint flushing of the barrier, a submersible fibre optic camera was used to inspect the integrity of the joints prior to the sealing process, Figure 4.

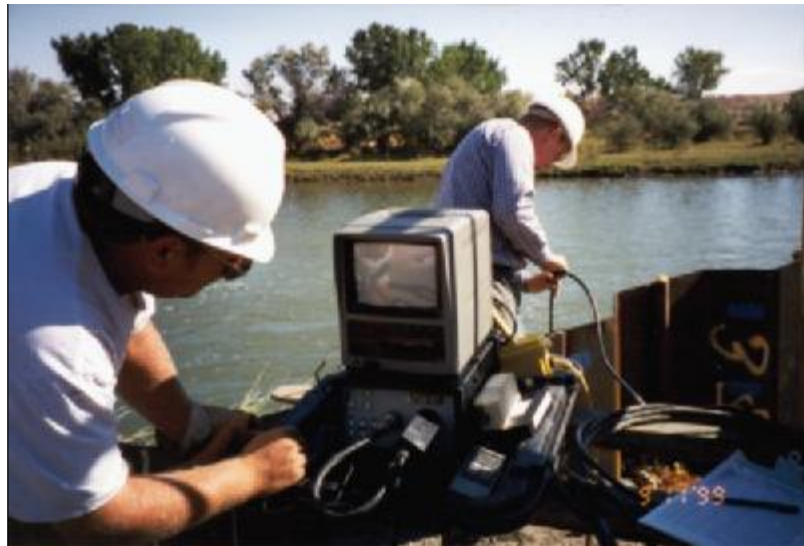
**Figure 4: Typical Video Inspection**
