SOURCE ZONE ISOLATION

FORMER WOOD PRESERVER SITE

Case History, No. 28

November, 2000

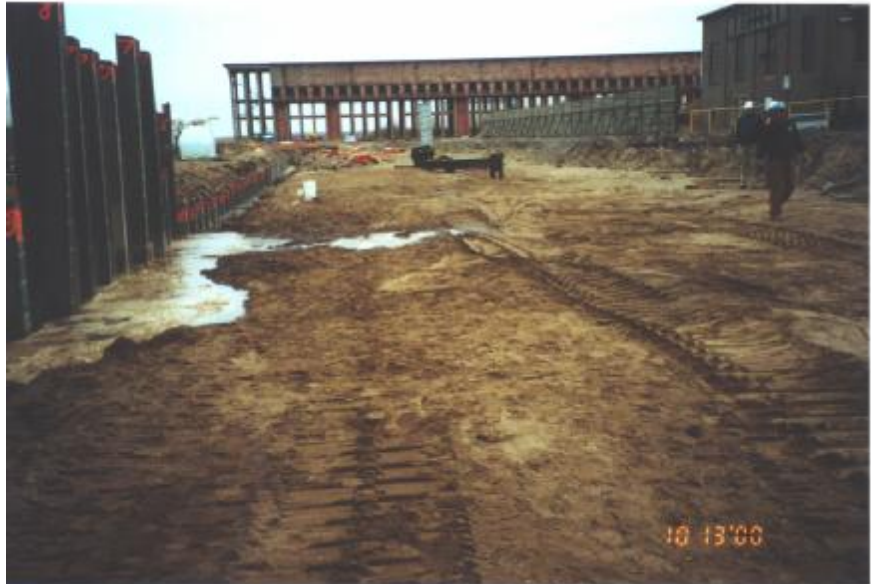
Figure 1: Barrier Along the Pier (Right)

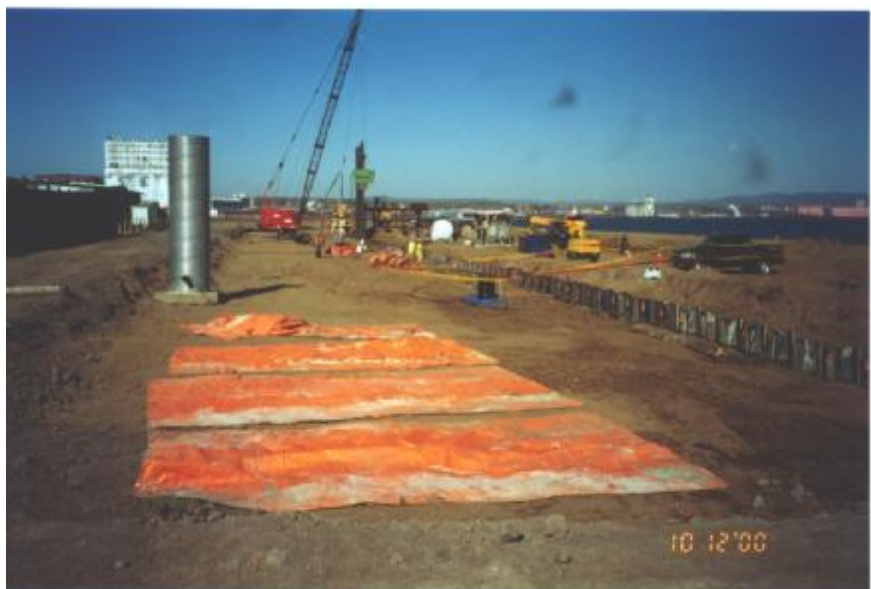
Figure 2: Reclaimed Land from Lake Superior

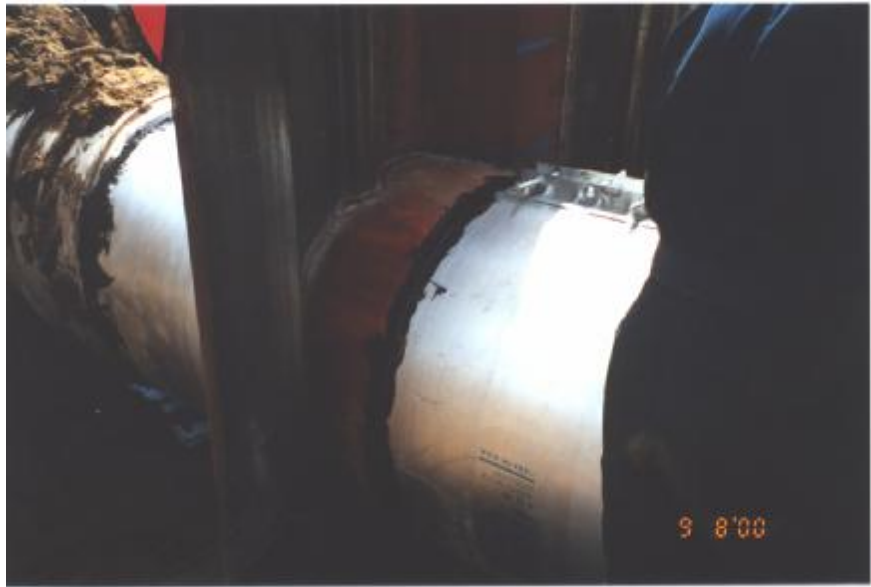
Figure 3: 900mm Penetration

structural properties. The containment system is a 3 sided continuous cutoff wall that was terminated at the existing clay berm located up gradient of the pier. Four penetrations through the cutoff wall accommodated a 900mm storm sewer line and a 100mm cooling water line (see Figure 3 for a 900mm penetration). A custom corner was fabricated to accommodate any future extension to the barrier wall. To provide the highest level of quality assurance, a submersible fibre optic camera was used to inspect the integrity of approximately 1 in 50 joints. All of the joints were sealed using WBS 301 cementitious based grout because of its strength and resistivity to degradation. Over 1,000 Waterloo Barrier® sheet piles were installed and sealed, and upon completion of the installation, the barrier was buried along its entire length. The project resulted in the reclamation of a substantial amount of land from Lake Superior for use by the wood preservation company. Fish habitats were also constructed outside the barrier to improve the rehabilitation of the shoreline.

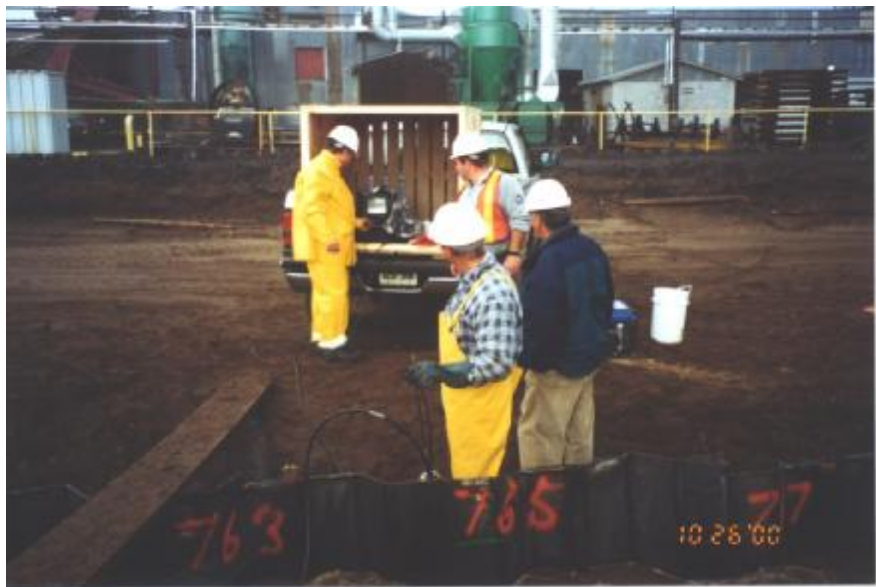
Figure 4: Fibre-Optic Video Inspection
