WATERLOO BARRIER[®] LANDFILL CUT-OFF WALL

SARNIA, ONTARIO

Case History, No. 56

June 2017

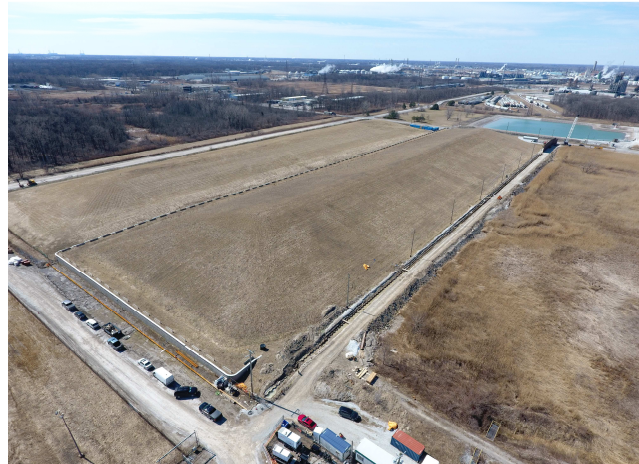
Figure 1. Landfill Aerial Photo

The former landfill seen in Figure 1, operated from 1950 to 1992. For over 20 years it received liquid industrial waste, including dense non-aqueous phase liquids (DNAPLs). The DNAPLs were comprised of varying concentrations of chlorinated organic compounds. For the remainder of the landfill life span (1972 to 1992), the majority of waste received consisted of contaminated soils and non-hazardous waste. Leachate collection and treatment costs were extremely costly due to the amount of groundwater flowing through the landfill.

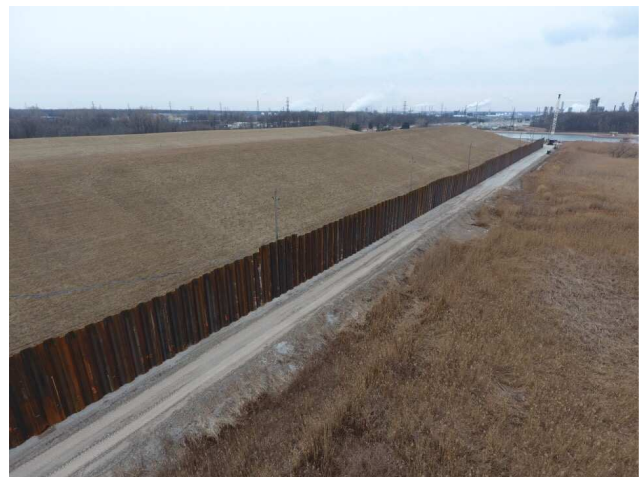
Figure 2. Raked Sheets – North Wall

To combat this problem, sheets along the northern edge of the landfill were installed in three stages. Initially they were laced and driven using a vibratory hammer to the elevation seen in figure 2. Second, an impact hammer was used to push the sheets down to the ground elevation. At that elevation, the crane could travel back over the wall to the starting point, see Figure 3. Finally, a narrow, 1-meter deep trench was dug on either side of the sheets to allow the impact hammer to install the Waterloo Barrier® to the final elevation. Once complete, the Waterloo Barrier® cutoff wall was proven successful in reducing the groundwater flow into the landfill. With reduced leachate accumulation, the resulting treatment costs decreased significantly.

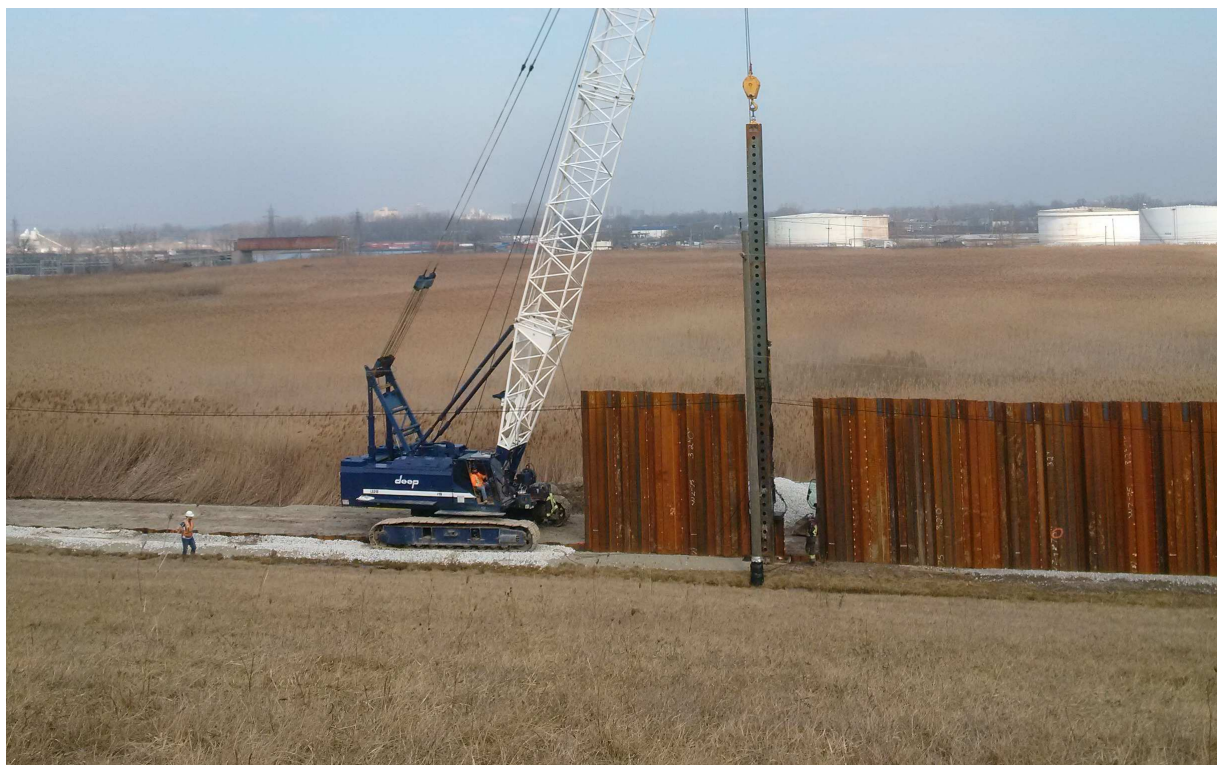
Figure 3. Stage 2 of North Wall Installation
