WATERLOO BARRIER[®]

IN SITU CHEMICAL OXIDATION

EAST LONGMEADOW, MA

Case History, No. 57

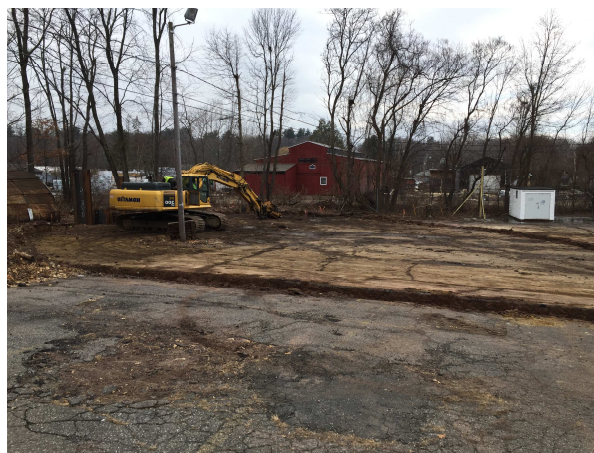
Figure 1. Historic Dumping Area

A former manufacturing plant in Massachusetts had a heavily contaminated area at the back of the property. This contamination was due to leaking underground storage tanks, and a history of improper equipment disposal. The contaminated groundwater was migrating off site.

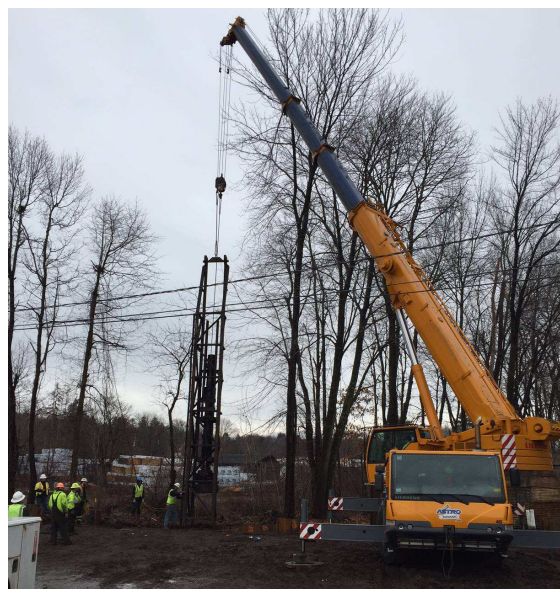
Figure 2. Impact Hammer

It was concluded that installing a WEZ95 Waterloo Barrier[®] cell, in combination with an In Situ Chemical Oxidation (ISCO) system, would be an effective solution to prevent any further migration off site, and quickly remove the contaminants. Approximately 8,054 square feet of WEZ95 Waterloo Barrier[®] sheet piling was installed around the contaminated area (See Figure 1). Waterloo Barrier[®] sheets were selected due to the low hydraulic conductivity provided by the system (10^{-7} cm/sec or less).
