IN SITU TREATMENT

Funnel-and-Gate™ System

Denver Federal Centre

Case History, No. 13

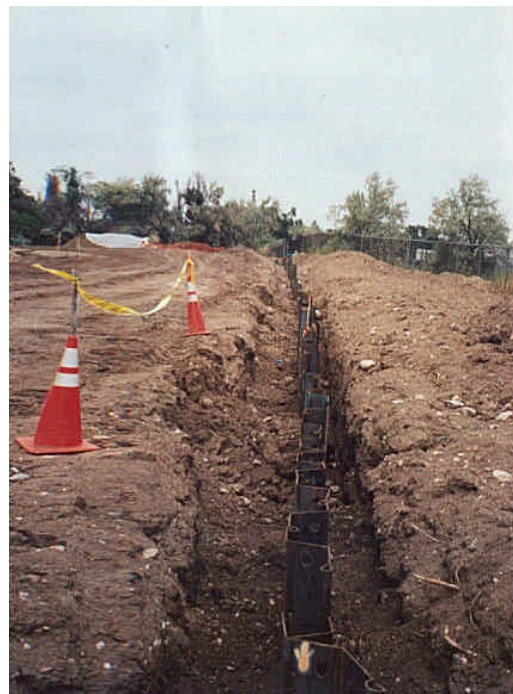
Figure 1. Funnel in Trench

A Funnel-and-Gate™ in situ passive treatment system was selected using the EnviroMetal Process for the gate treatment media. Waterloo Barrier® WZ75 sheet piling was used to form the funnel. The overall length of the system was approximately 1,200 lineal feet, with the four treatment gates evenly distributed along the funnel. A shallow trench was excavated along the line of the funnel to allow the pile to be driven below grade so that there would be no visual sign of the system after completion of construction. For half of the length of the installation, the system was bounded by a pond on one side and by a major road on the other, making access difficult. Part of the funnel is shown in Figure 2. Gate number three is just visible in the tree line at the top of the photo.

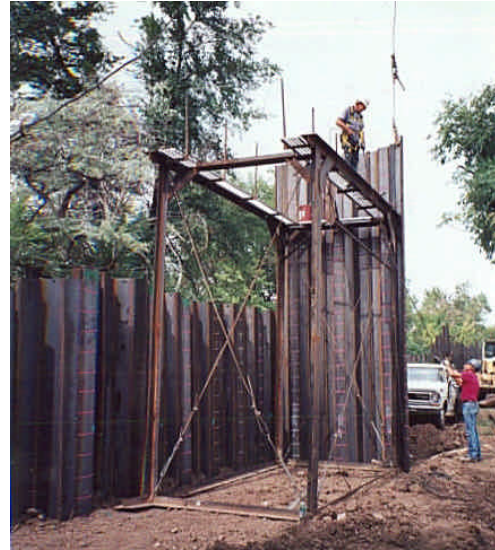
Figure 2. Gate Template

Construction sequence was critical for this project. First the funnel wall had to be driven to sufficient depth to allow the gates to be constructed. Templates were used to ensure proper alignment of the gates. The Waterloo Barrier® WZ75 sheet piling on the up gradient and down gradient faces of the gates was temporarily sealed during excavation and media placement to keep the cells dry. Once the media was in place in the treatment cells, the up and down gradient piles were removed and used to complete the funnel section at the end of the barrier. Construction of a typical cell and the template is shown in Figure 2.

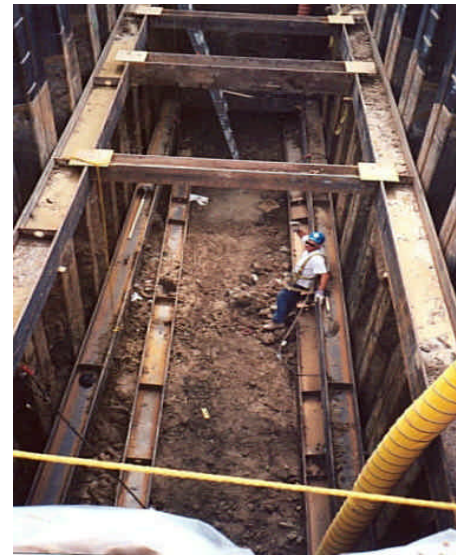
Figure 3. Excavated Gate

During the initial site characterization, varying groundwater flow rates were documented. The variable rates were attributed to non-homogeneous sediments present on the site. Since treatment of the contaminated groundwater is dependent upon residence time in the EnviroMetal iron media, the thickness of the iron media was different from gate to gate. This was accomplished using temporary dividers in the gate and placing washed pea gravel on the up gradient and down gradient faces of the iron as a sandwich, with the iron in the middle. The shoring and the guide beams for the temporary dividers are shown in Figure 3.
