# SHORING & CUTOFF WALL SYSTEM

FORMER BULK PLANT

Case History, No. 19

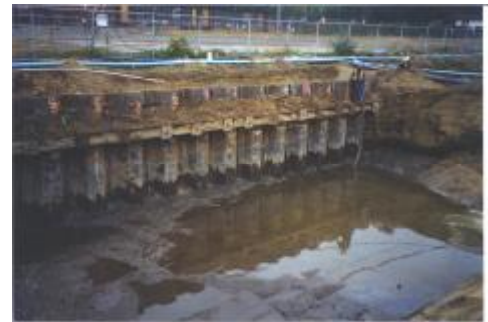
Figure 1. Tie-back Anchor System

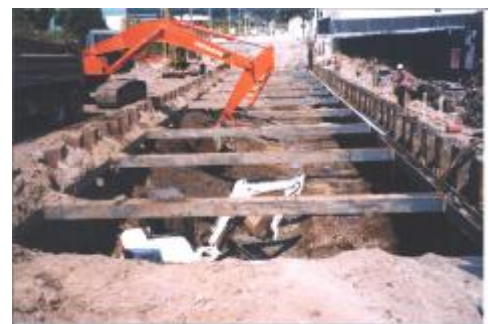
Figure 2. Walers and Struts System
