ENHANCED PUMP AND TREAT

FORMER CHEMICAL MANUFACTURING PLANT

Case History, No. 43

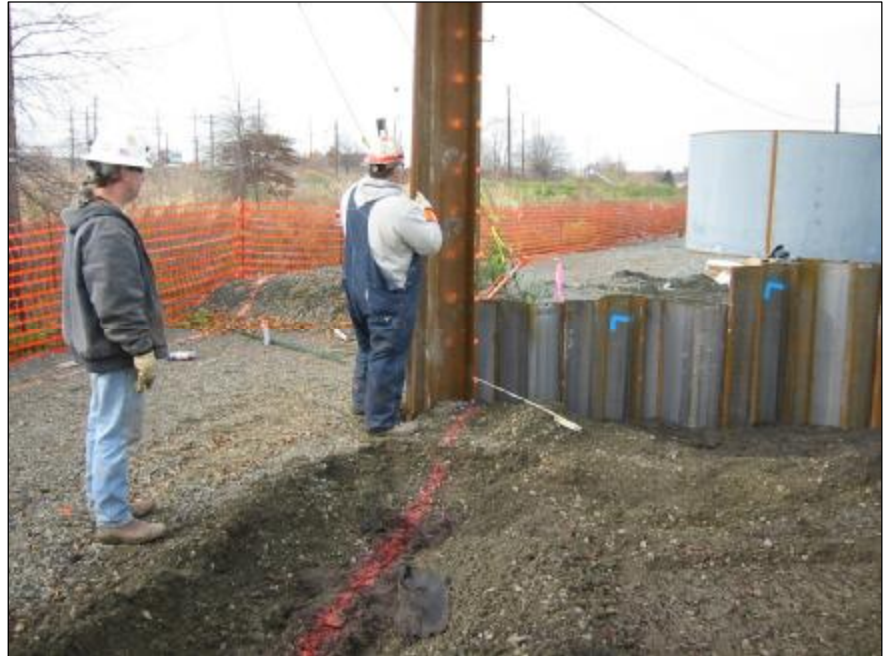
Figure 1: Installation of Custom Bent Sheet

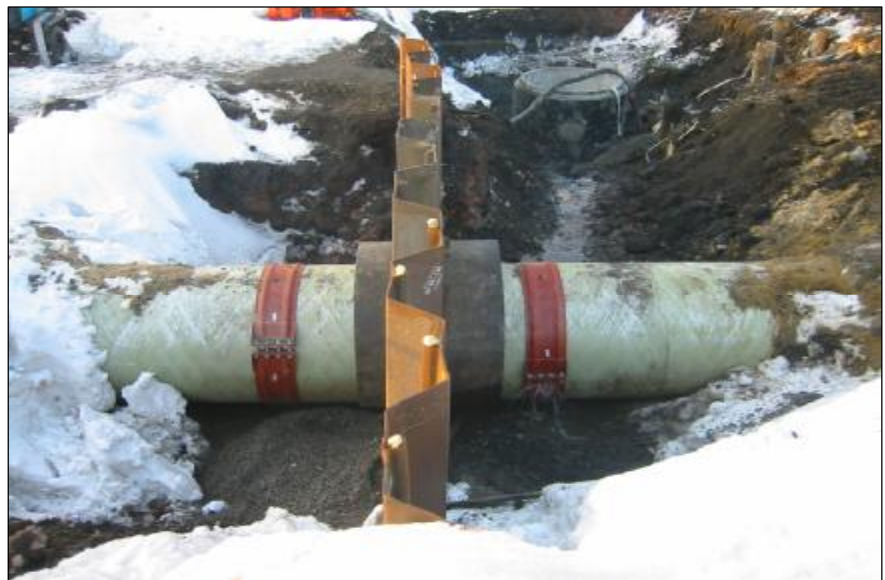
Figure 2: 60-inch Penetration

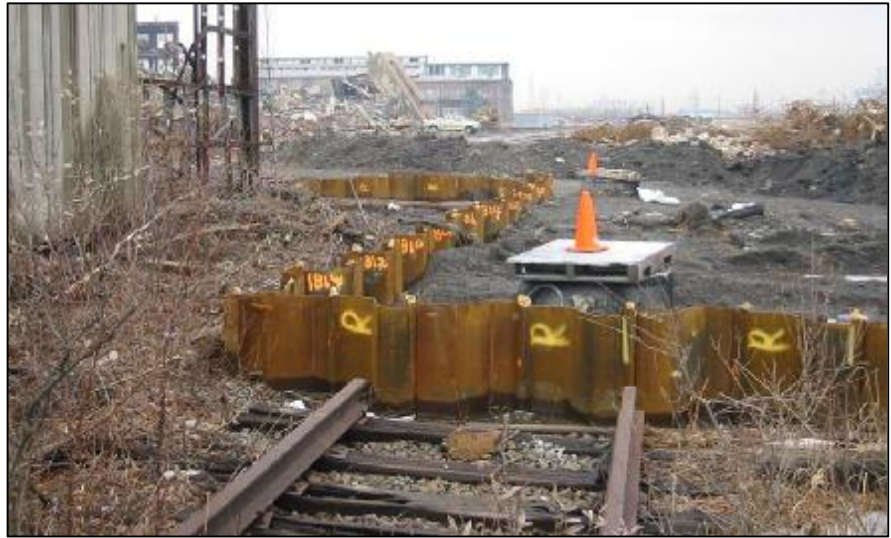
Figure 3: Barrier Through Former Plant

The Waterloo Barrier[®] containment system was selected because of its low permeability (10^{-7} cm/s) and the warranty associated with it. In addition, the barrier was much less expensive than other remediation options. The barrier was installed along the boundary in order to encompass the entire property. To conform to the irregular property line, 17 custom-bent corner sheet piles were employed to follow the desired layout (see Figure 1). There were 9 penetrations through the barrier to accommodate existing and future services at various locations, with diameters varying from 8" to 60" (see Figure 2). Several temporary road crossings were built over the barrier during construction to allow uninterrupted emergency access to the site. Over 4,000 Waterloo Barrier[®]

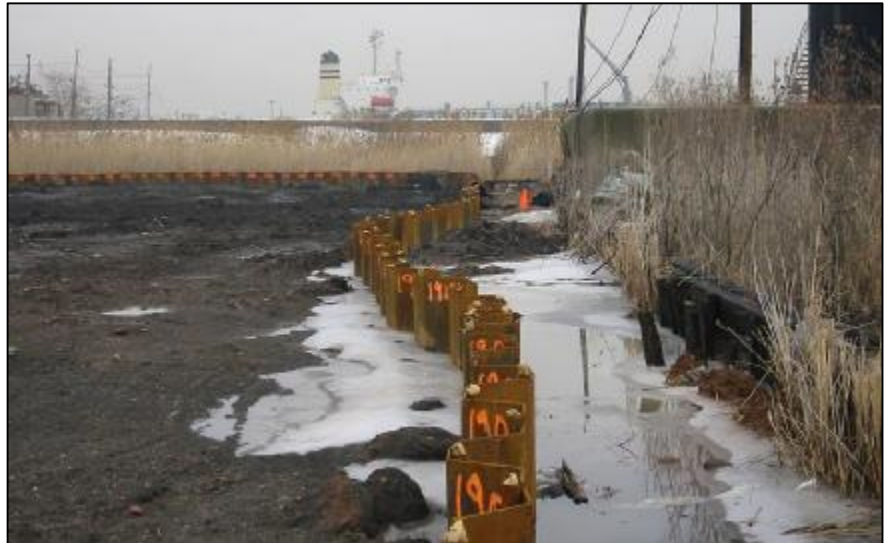
Figure 4: Barrier Along Property Boundary
